## Case Study Soldier Piles Drilled in Solid Rock

**Job:** SR 508 Bear Canyon Slope Repair

**Location:** Morton, Washington

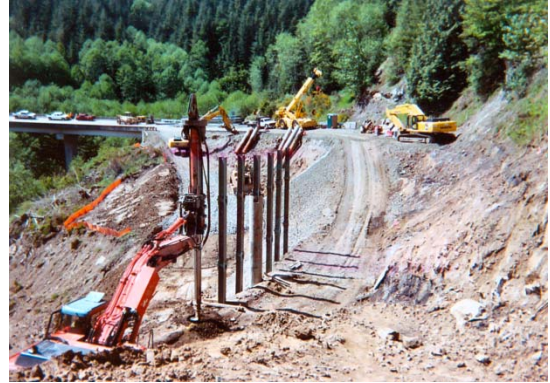
SR 508 is a two lane highway hung on the side of the mountain as it curves thru Bear Canyon. The overburden, saturated with rain water from the November storm, slid down the 20 degree rock slope leaving the residents with a 25 mile detour.

The Washington State Department of Transportation engineers designed a soldier pile wall embedded in the rock slope with up to five rows of tiebacks holding the overburden onto the hillside.

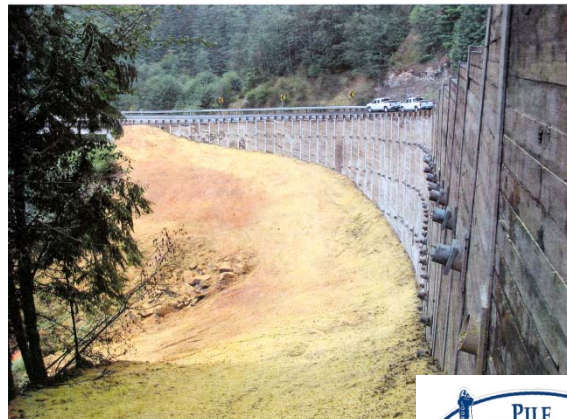
Pile Contractors drilled and placed the 12 x 74 # X 60' steel beams using a LoDrill HTFB-60 mounted on a Hitachi EX400LC-3 carrier. The steep slope and lack of overburden made drilling difficult (the LoDrill wanted to slide down the ravine) and placing the pile difficult as the wall is on a radius and the top of the pile was 36' above placement elevation. Due to limited access the piles were placed with a Komatsu 400 Excavator and then Grove 50 ton Rough Terrain crane. As the "belly" or deep section of the wall was built out, the tiebacks and lagging were installed from above and below.
